**Easter Sunday Tornado Outbreak 4/12/2020**  
**Report by: Don Wheeler, Meteorologist**

**...TORNADO EMERGENCY FOR MONROE LOUISIANA AND NORTHEAST OUACHITA PARISH...**

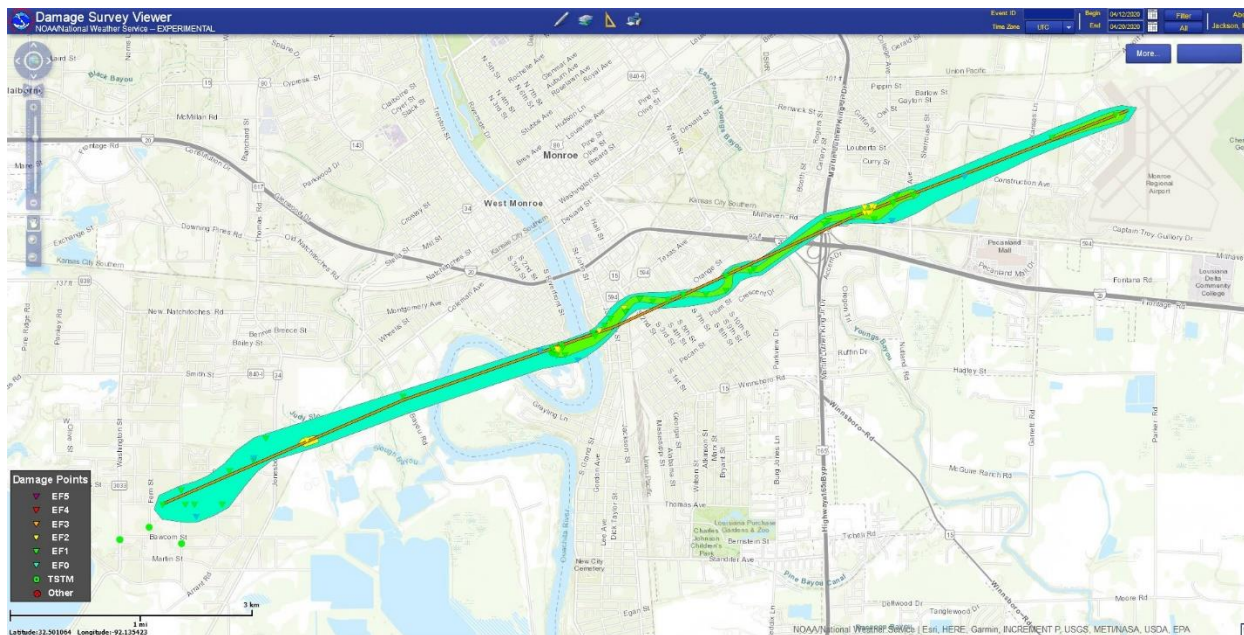
Figure 6 Damage Path from National Weather Service Survey

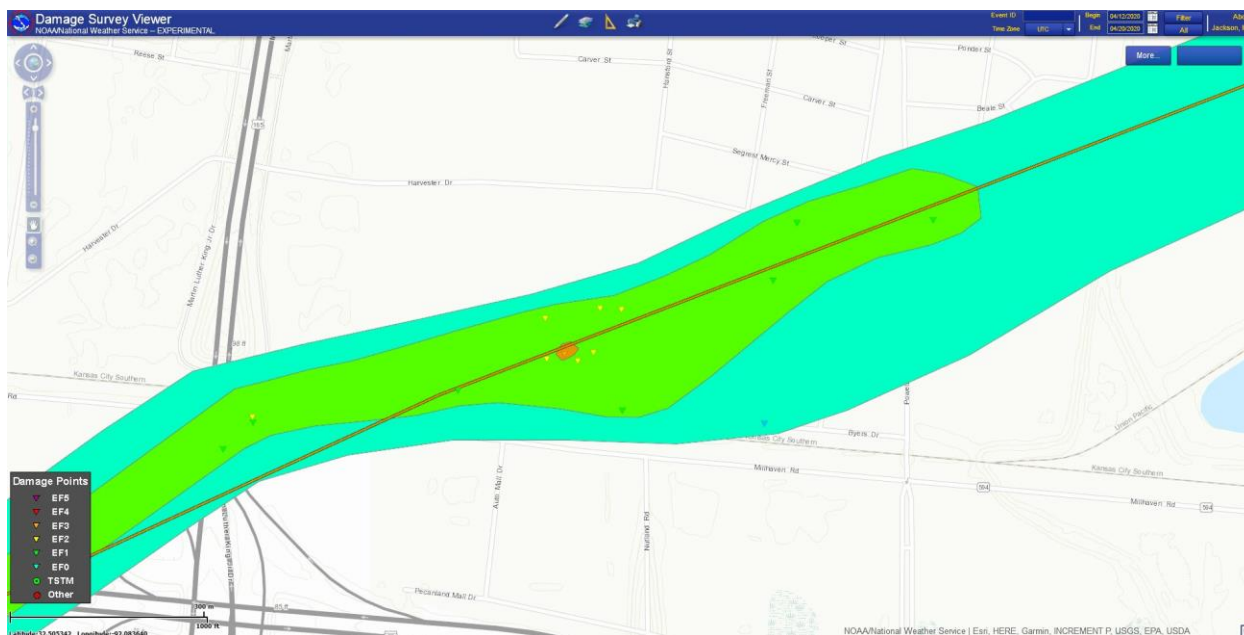
Figure 7 Isolated Area of EF3 Damage in Monroe

THE WORST DAMAGE FROM THE TORNADO THEN OCCURRED ALONG ORCHID DR WHERE IT RIPPED THE ROOF OFF OF 3 HOMES AND COLLAPSED MUCH OF THE EXTERIOR WALLS OF ONE OF THE HOMES. THE WORST DAMAGE WAS ALONG A VERY NARROW CORRIDOR IN THIS SUBDIVISION AND IS BELIEVED THAT A MESOVORTEX WITHIN THE TORNADO LED TO THIS NARROW CORRIDOR OF MORE INTENSE DAMAGE. AFTER THE TORNADO MOVED OUT OF THIS SUBDIVISION, DAMAGE BECAME MORE SPORADIC AND THE TORNADO TOUCHED SEVERAL TIMES BEFORE IT DESTROYED A METAL HANGAR HOUSING SEVERAL AIRPLANES AT THE MONROE REGIONAL AIRPORT. THE TORNADO THEN

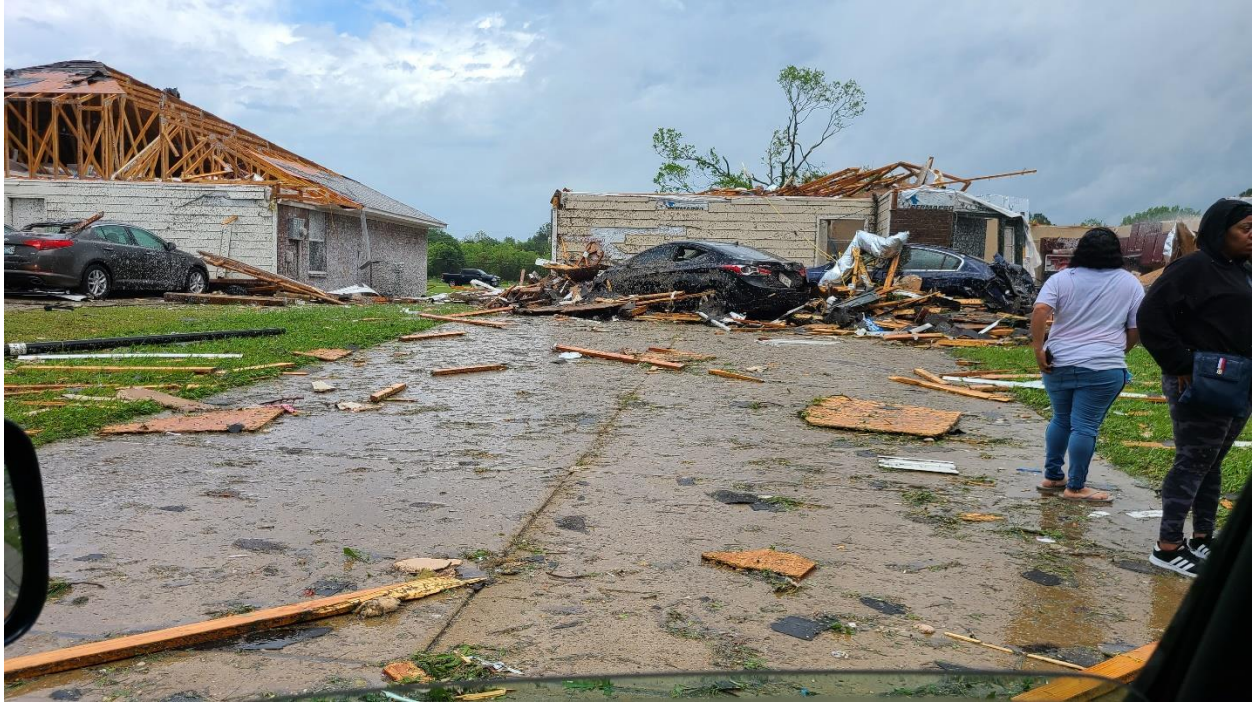
The storm that struck West Monroe/Monroe touched down in Bawcomville producing EF1 damage. It quickly moved northeast causing further damage at Lazarre Point in West Monroe before crossing the river in south Monroe near Jackson Street. The tornado continued to cause considerable damage to homes and businesses. The tornado moved across I-20 and U.S. 165 where it produced EF3 damage to homes near Powell Avenue just northwest of Pecanland Mall. It is possible that here an intense suction vortex (mesovortex) formed that caused a small area of EF3 damage. Roofs were completely removed from several homes with partial collapse of exterior walls.

*Figure 8 EF3 Damage in Monroe Subdivision. Photo by Keith Brooks*

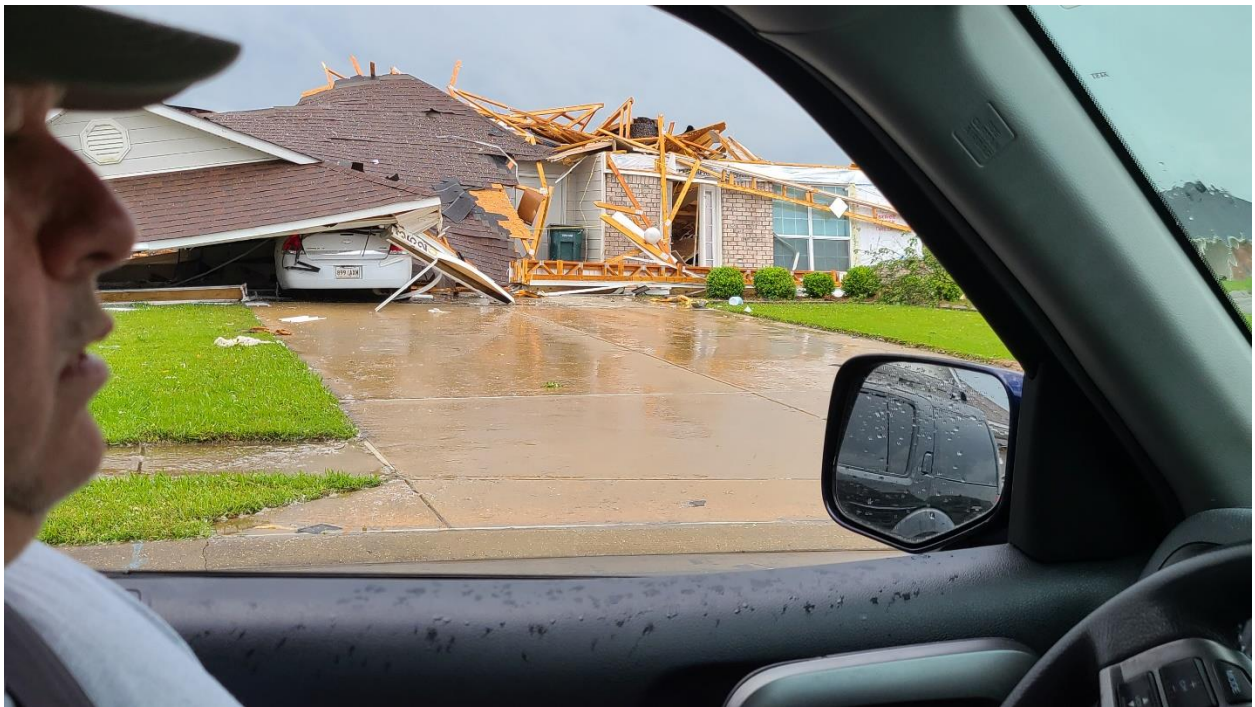
*Figure 9 EF3 Damage in Monroe Subdivision. Photo by Keith Brooks*

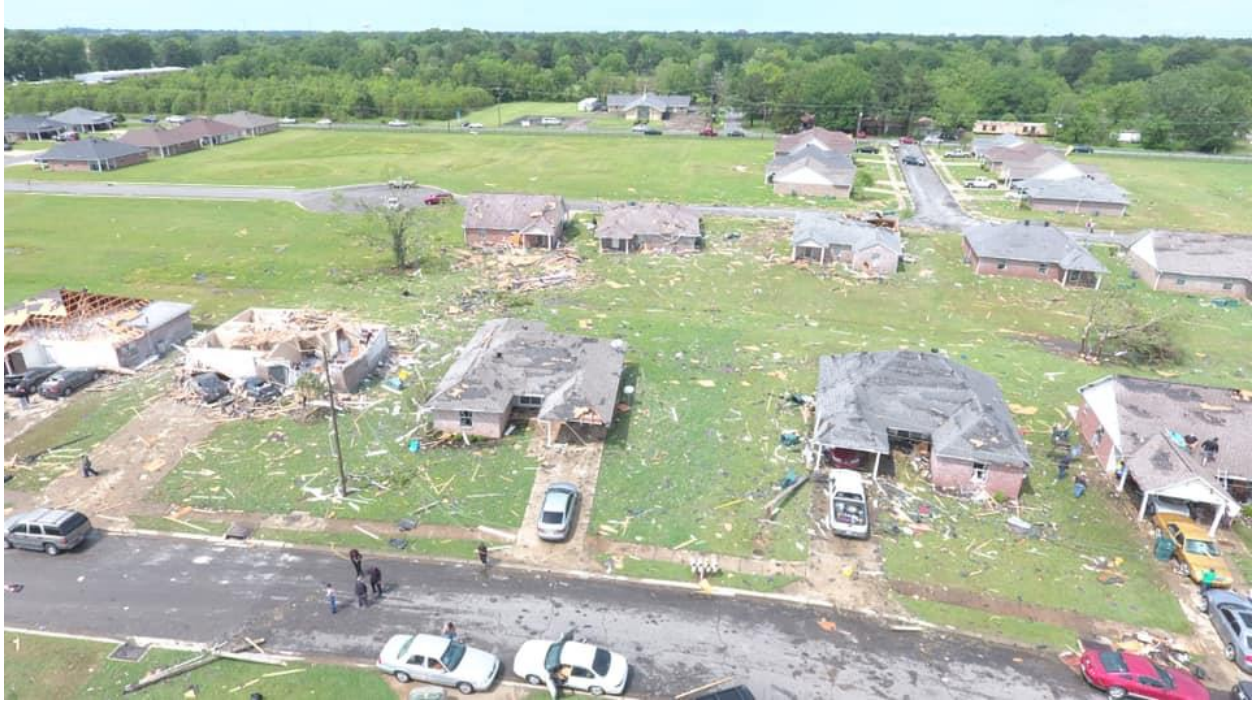
Figure 10 Aerial Image of Monroe Damage Courtesy of Kita Wright/ProWorks Productions LLC

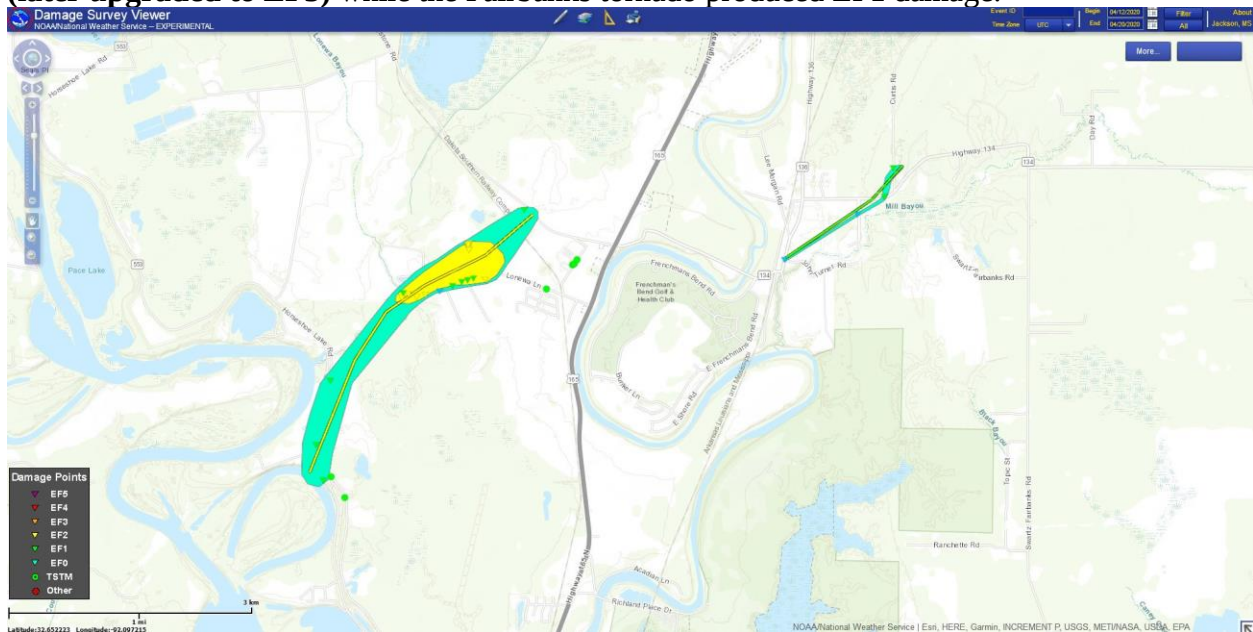
Figure 11 Sterlington/Fairbanks Tornado Damage Paths from National Weather Service Surveys

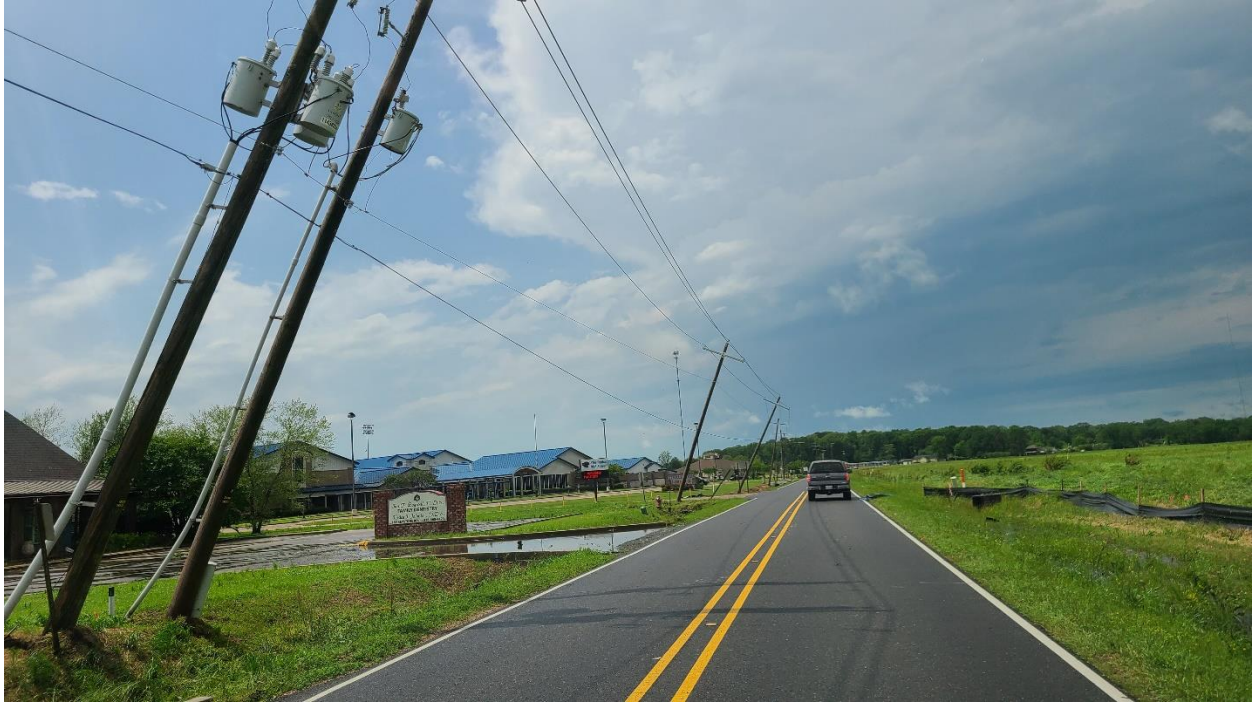
*Figure 12 Light Pole Damage and Damage to Sterlington High School (left of image. Photo by Keith Brooks*

SUMMARY: THE TORNADO FIRST TOUCHED DOWN IN A FORESTED AREA NEAR HORSESHOE LAKE RD, UPROOTING HUNDREDS OF TREES. WINDS INCREASED AND TREE DAMAGE BECAME MORE WIDESPREAD AS TREES WERE UPROOTED, SNAPPED, AND EVEN A TREE PARTIALLY DEBARKED OFF OF END OF LINE RD. THE TORNADO TOOK THE ROOF OFF OF TWO SINGLE FAMILY HOMES AND DESTROYED AN OUTBUILDING ALONG END OF LINE RD. IT THEN DAMAGED SHINGLES AS APPROXIMATELY TEN HOUSES AS IT TRACKED ALONG LONEWA LANE AND ROSE PLANTATION LANE. ALONG LONEWA LANE, THE TORNADO SNAPPED FOUR CONCRETE POLES BEFORE LIFTING JUST BEFORE IT CROSSED KEYSTONE RD.

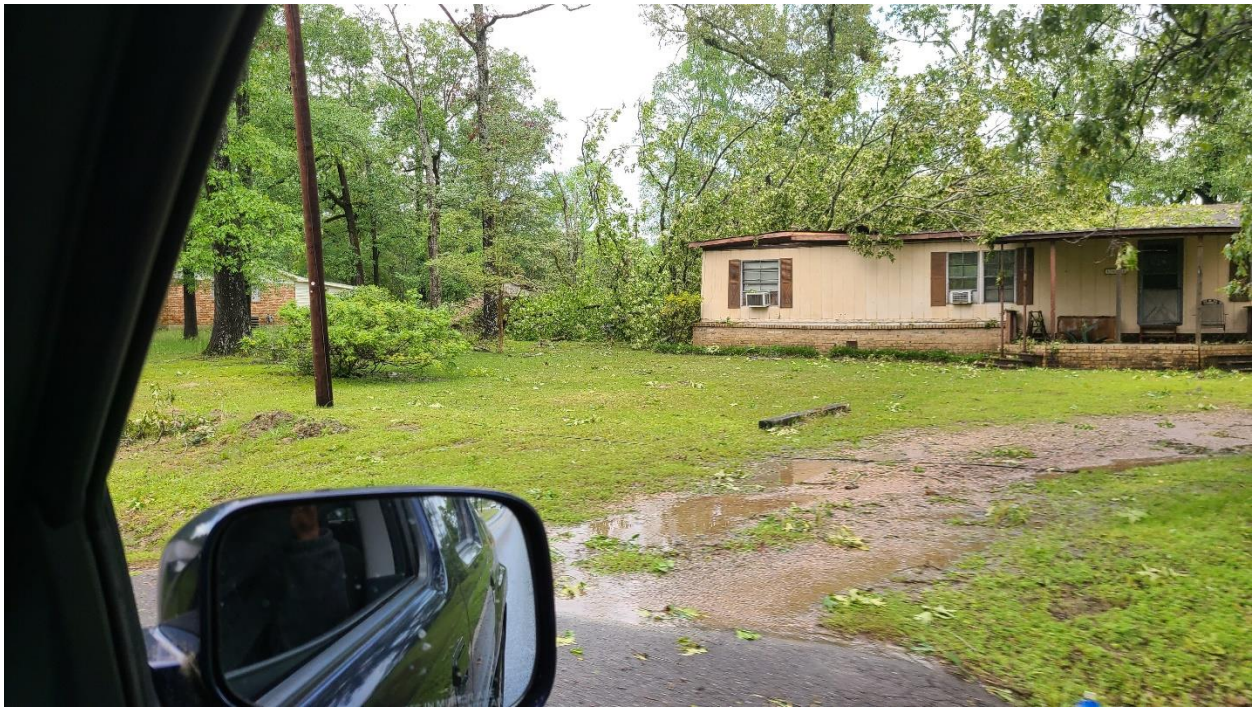
*Figure 13 Tree Damage in Fairbanks. Photo by Keith Brooks*

SUMMARY: A TORNADO BRIEFLY TOUCHED DOWN IN FAIRBANKS ALONG THE CORNER OF JOHN TURNER RD AND HIGHWAY 134. IT CONTINUED ON TO CROSS HIGHWAY 134 AGAIN AND CURTIS RD. BEFORE LIFTING. APPROXIMATELY 30 TREES WERE UPROOTED AND SNAPPED IN A CONVERGENT PATTERN ALONG THE PATH.
