**Easter Sunday Tornado Outbreak 4/12/2020**  
**Report by: Don Wheeler, Meteorologist**

**...TORNADO EMERGENCY FOR MONROE LOUISIANA AND NORTHEAST  
OUACHITA  
PARISH...**

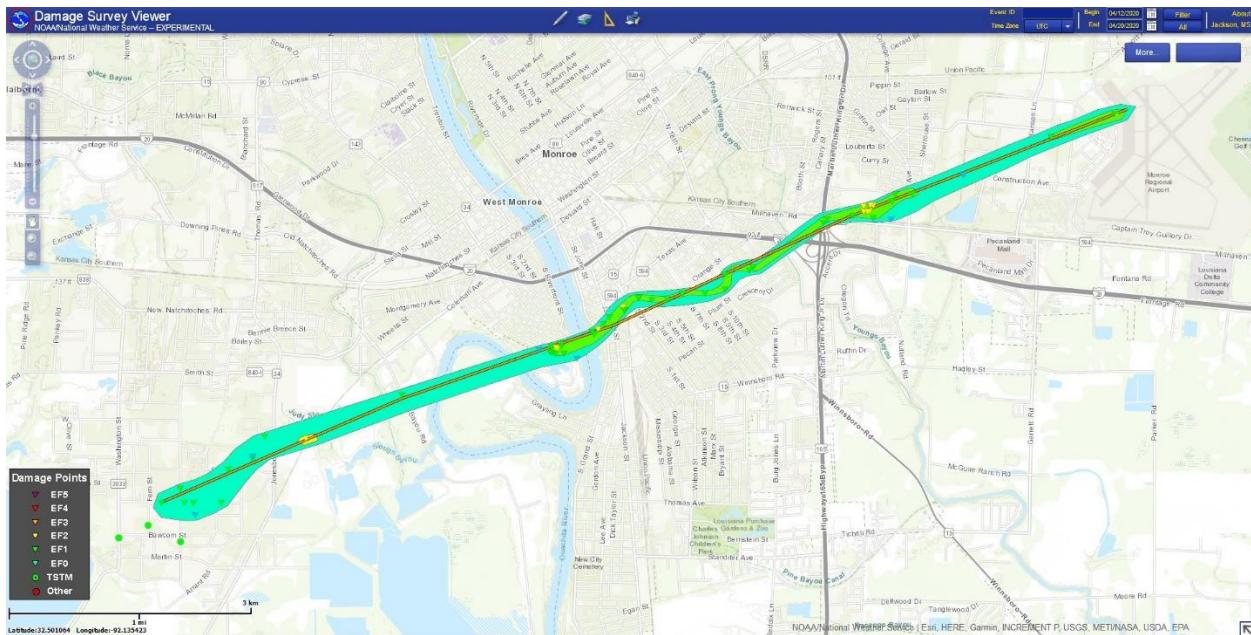
Figure 6 Damage Path from National Weather Service Survey

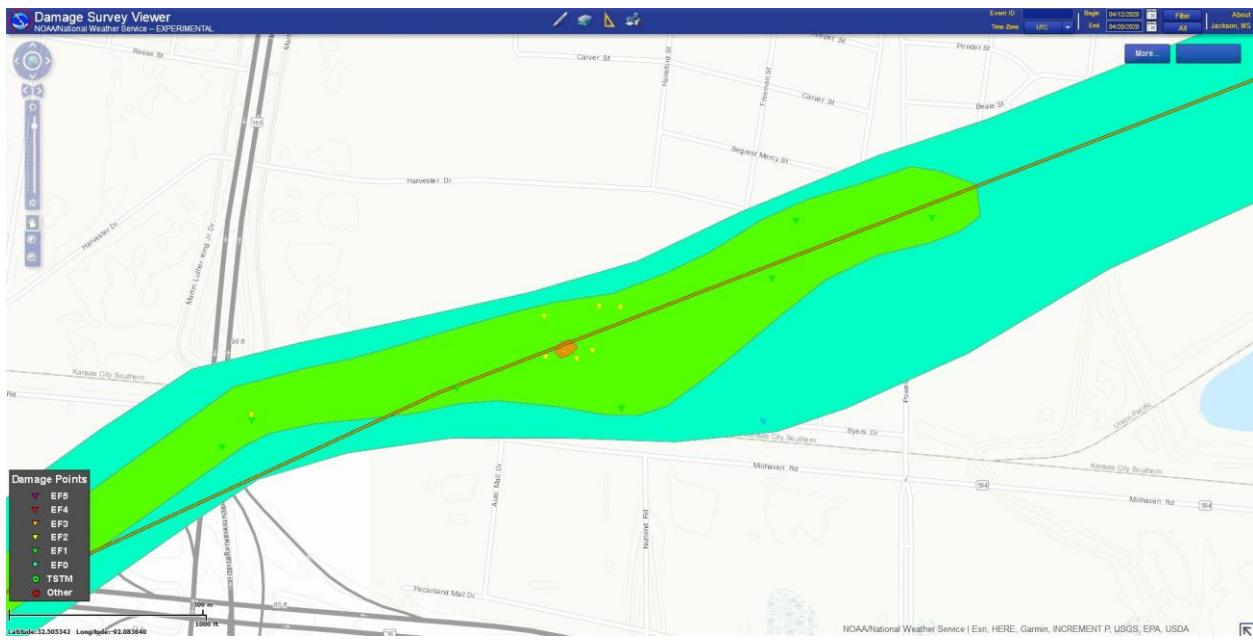
Figure 7 Isolated Area of EF3 Damage in Monroe

THE WORST DAMAGE FROM THE TORNADO THEN OCCURRED ALONG ORCHID DR WHERE IT RIPPED THE ROOF OFF OF 3 HOMES AND COLLAPSED MUCH OF THE EXTERIOR WALLS OF ONE OF THE HOMES. THE WORST DAMAGE WAS ALONG A VERY NARROW CORRIDOR IN THIS SUBDIVISION AND IS BELIEVED THAT A MESOVORTEX WITHIN THE TORNADO LED TO THIS NARROW CORRIDOR OF MORE INTENSE DAMAGE. AFTER THE TORNADO MOVED OUT OF THIS SUBDIVISION, DAMAGE BECAME MORE SPORADIC AND THE TORNADO TOUCHED SEVERAL TIMES BEFORE IT DESTROYED A METAL HANGAR HOUSING SEVERAL AIRPLANES AT THE MONROE REGIONAL AIRPORT. THE TORNADO THEN LIFTED AS IT CROSSED A RUNWAY OF THE AIRPORT.

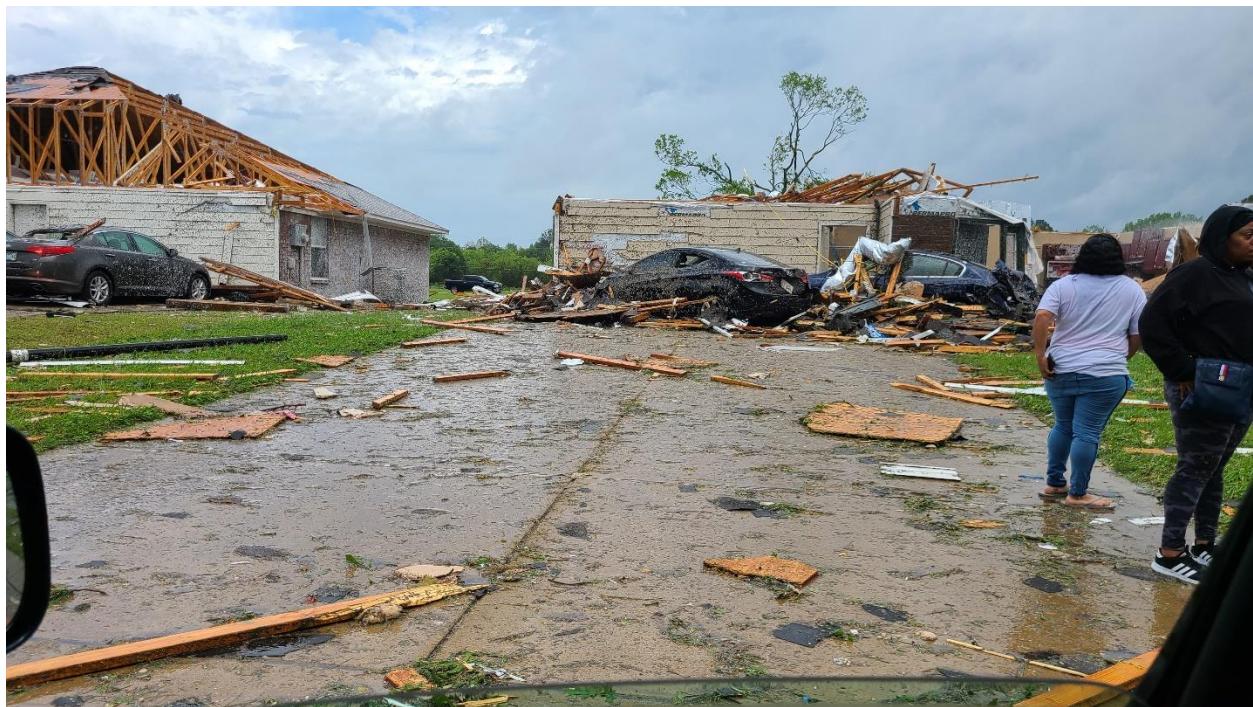
The storm that struck West Monroe/Monroe touched down in Bawcomville producing EF1 damage. It quickly moved northeast causing further damage at Lazarre Point in West Monroe before crossing the river in south Monroe near Jackson Street. The tornado continued to cause considerable damage to homes and businesses. The tornado moved across I-20 and U.S. 165 where it produced EF3 damage to homes near Powell Avenue just northwest of Pecanland Mall. It is possible that here an intense suction vortex (mesovortex) formed that caused a small area of EF3 damage. Roofs were completely removed from several homes with partial collapse of exterior walls.

Figure 8 EF3 Damage in Monroe Subdivision. Photo by Keith Brooks

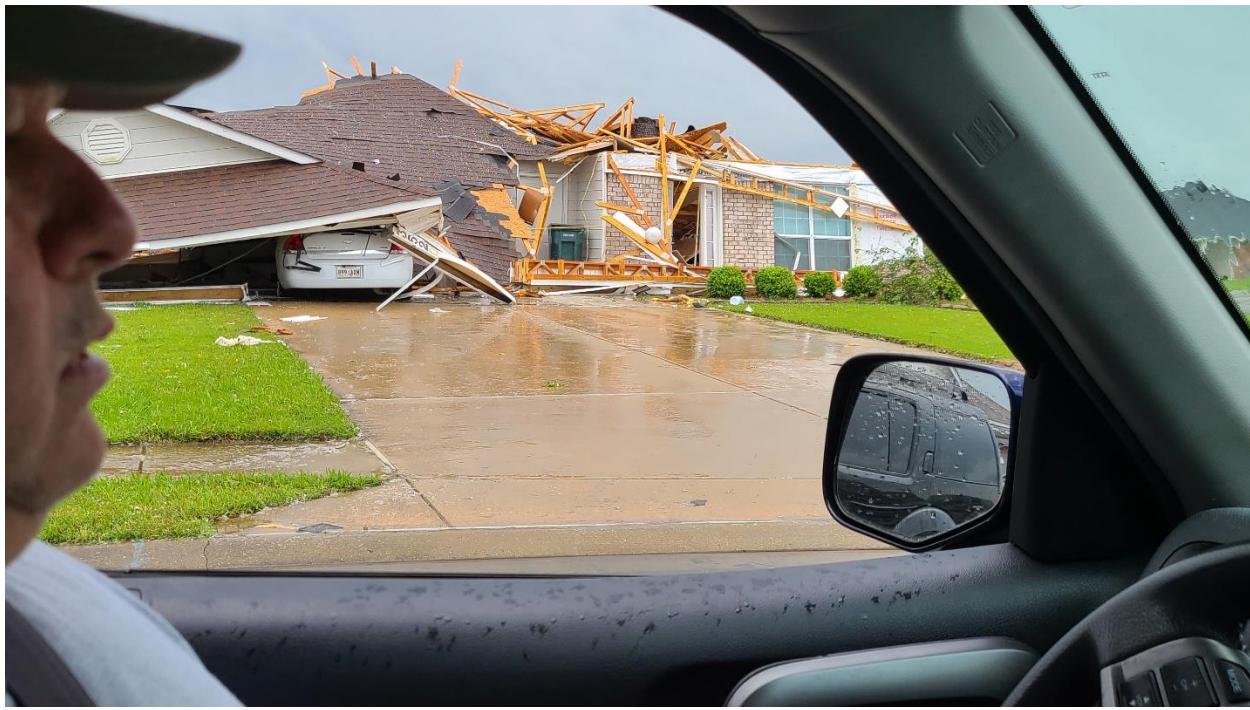
Figure 9 EF3 Damage in Monroe Subdivision. Photo by Keith Brooks

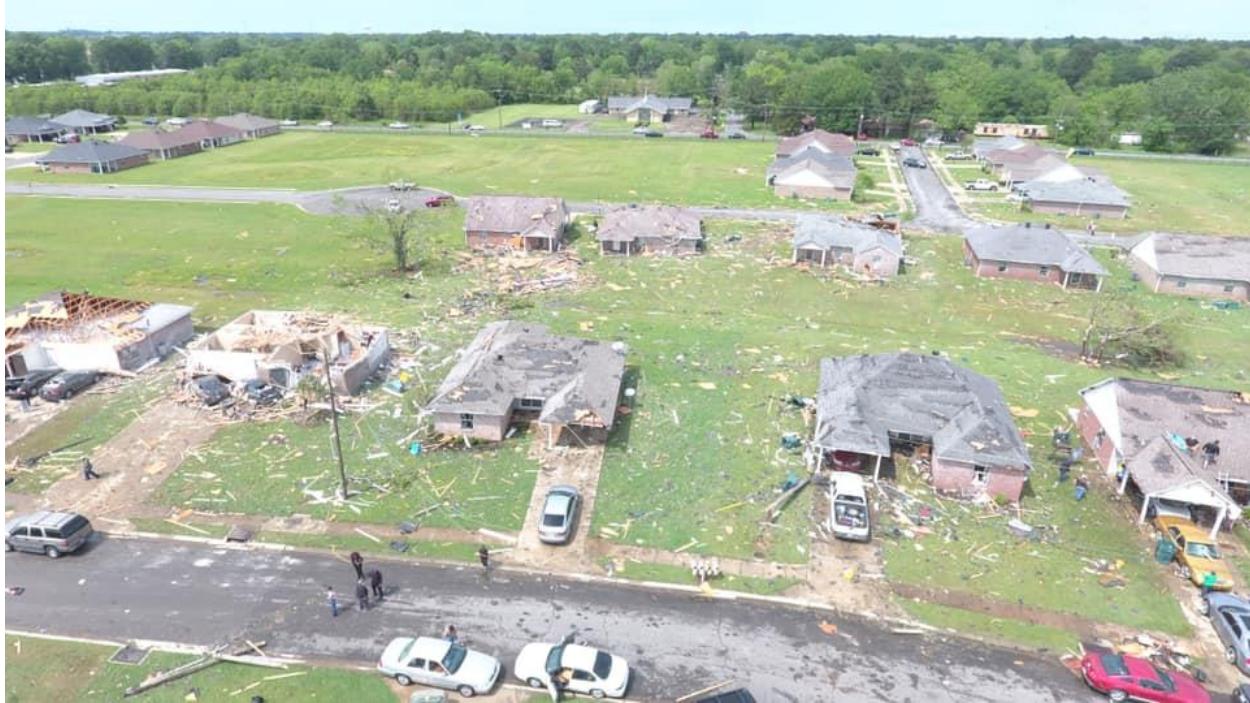
Figure 10 Aerial Image of Monroe Damage Courtesy of Kita Wright/ProWorks Productions LLC

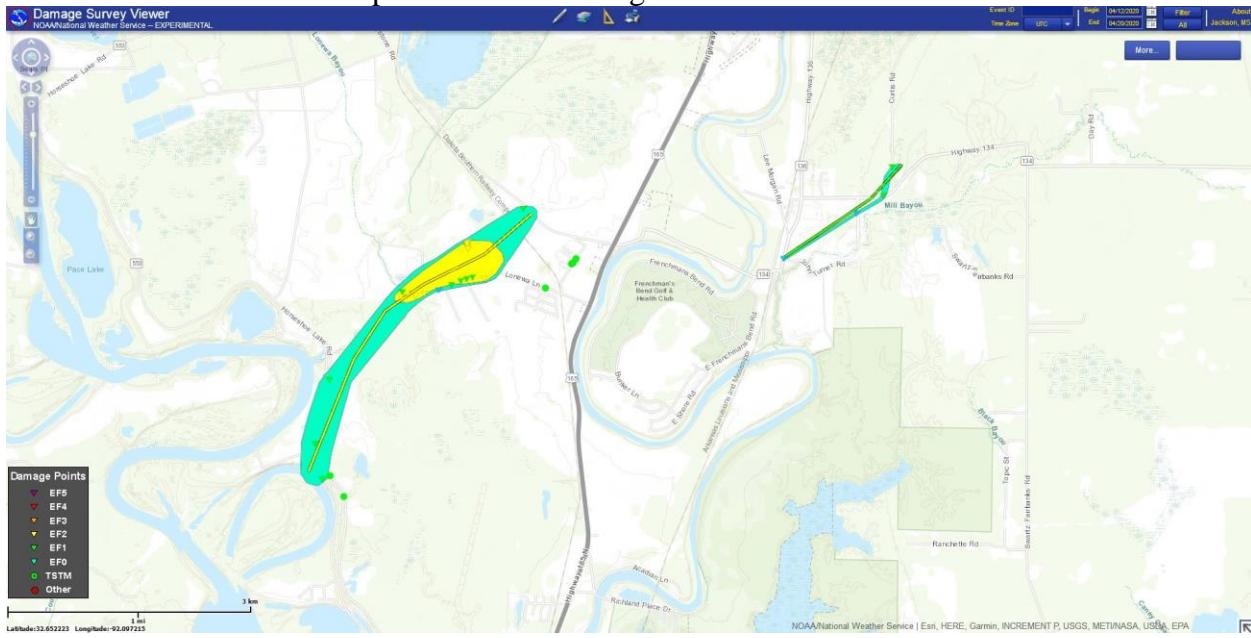
and the other produced tree and home damage in the community of Fairbanks just to the east-northeast of Sterlington. It appears that the first Sterlington tornado cycled out and lifted while another formed downstream to strike Fairbanks. The Sterlington tornado produced EF2 damage while the Fairbanks tornado produced EF1 damage.

Figure 11 Sterlington/Fairbanks Tornado Damage Paths from National Weather Service Surveys

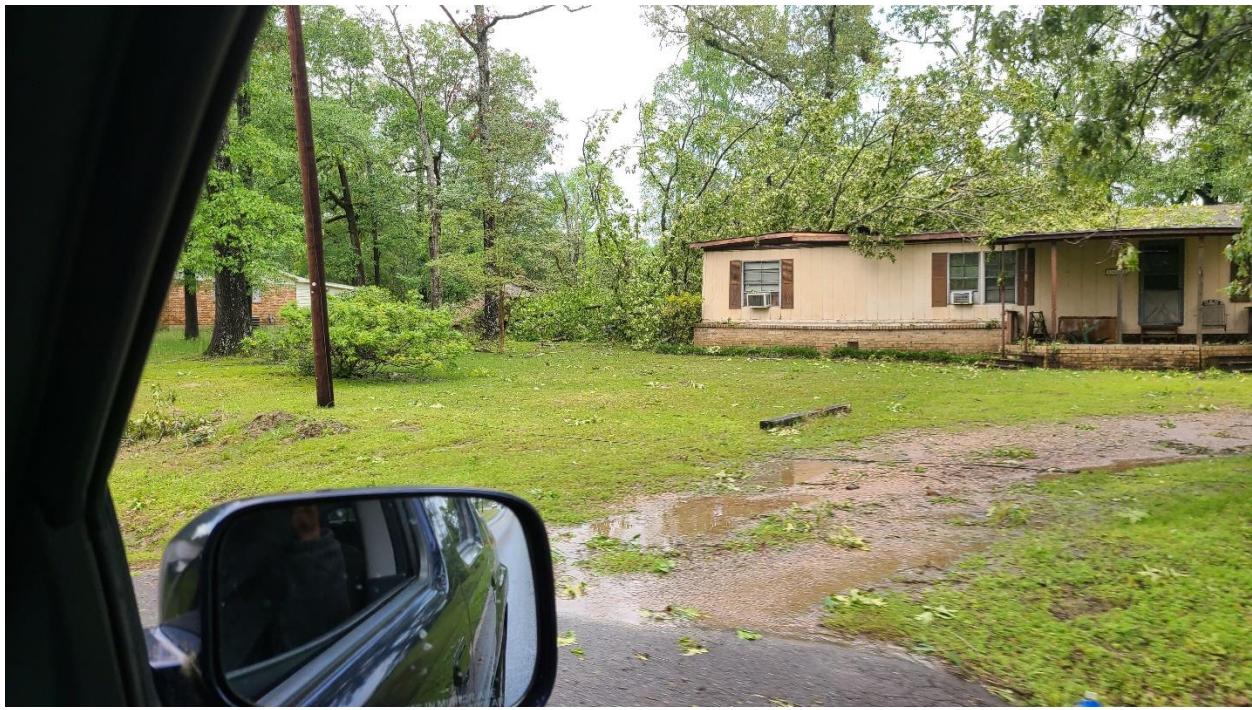
Figure 13 Tree Damage in Fairbanks. Photo by Keith Brooks

SUMMARY: A TORNADO BRIEFLY TOUCHED DOWN IN FAIRBANKS ALONG THE CORNER OF JOHN TURNER RD AND HIGHWAY 134. IT CONTINUED ON TO CROSS HIGHWAY 134 AGAIN AND CURTIS RD. BEFORE LIFTING. APPROXIMATELY 30 TREES WERE UPROOTED AND SNAPPED IN A CONVERGENT PATTERN ALONG THE PATH.
